Anti-Tip Brackets for Freestanding Ranges

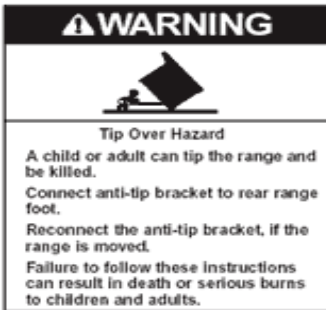
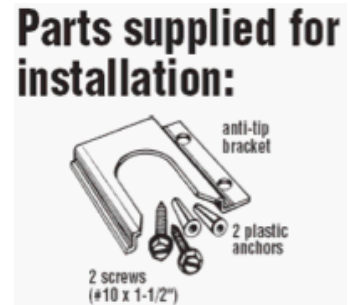
Anti-tip brackets are metal devices designed to prevent freestanding ranges from tipping. They are normally attached to a rear leg of the range or screwed into the wall behind the range, and are included in all installation kits. A unit that is not equipped with these devices may tip over if enough weight is applied to its open door, such as that from a large Thanksgiving turkey, or even a small child. A falling range can crush, scald, or burn anyone caught beneath.

- It may be possible to see a wall-mounted bracket by looking over the rear of the range. Floor-mounted brackets are often hidden, although in some models with removable drawers, such as 30" electric ranges made by General Electric, the drawers can be removed and a flashlight can be used to search for the bracket. Inspectors should beware that a visual confirmation does not guarantee that the bracket has been properly installed.

- Inspectors can firmly grip the upper-rear section of the range and tip the unit. If equipped with an anti-tip bracket, the unit will not tip more than several inches before coming to a halt. The range should be turned off, and all items should be removed from the stovetop before this action can be performed. It is usually easier to detect a bracket by tipping the range than through a visual search. This test can be performed on all models and it can confirm the functionality of a bracket.
